## BACKGROUND

Low water-cement ratio concretes are commonly used in bridge girders by TXDOT where high strength and low permeability are required. However, due to the low water-cement ratio and limited curing period of these pre-stressed girders, these mixtures may be more susceptible to **microcracking**.

This project was supported under TxDOT Project 0-6922, Evaluating Long-term Durability and Performance of Prestressed Concrete Beams with Extensive Surface Cracking.

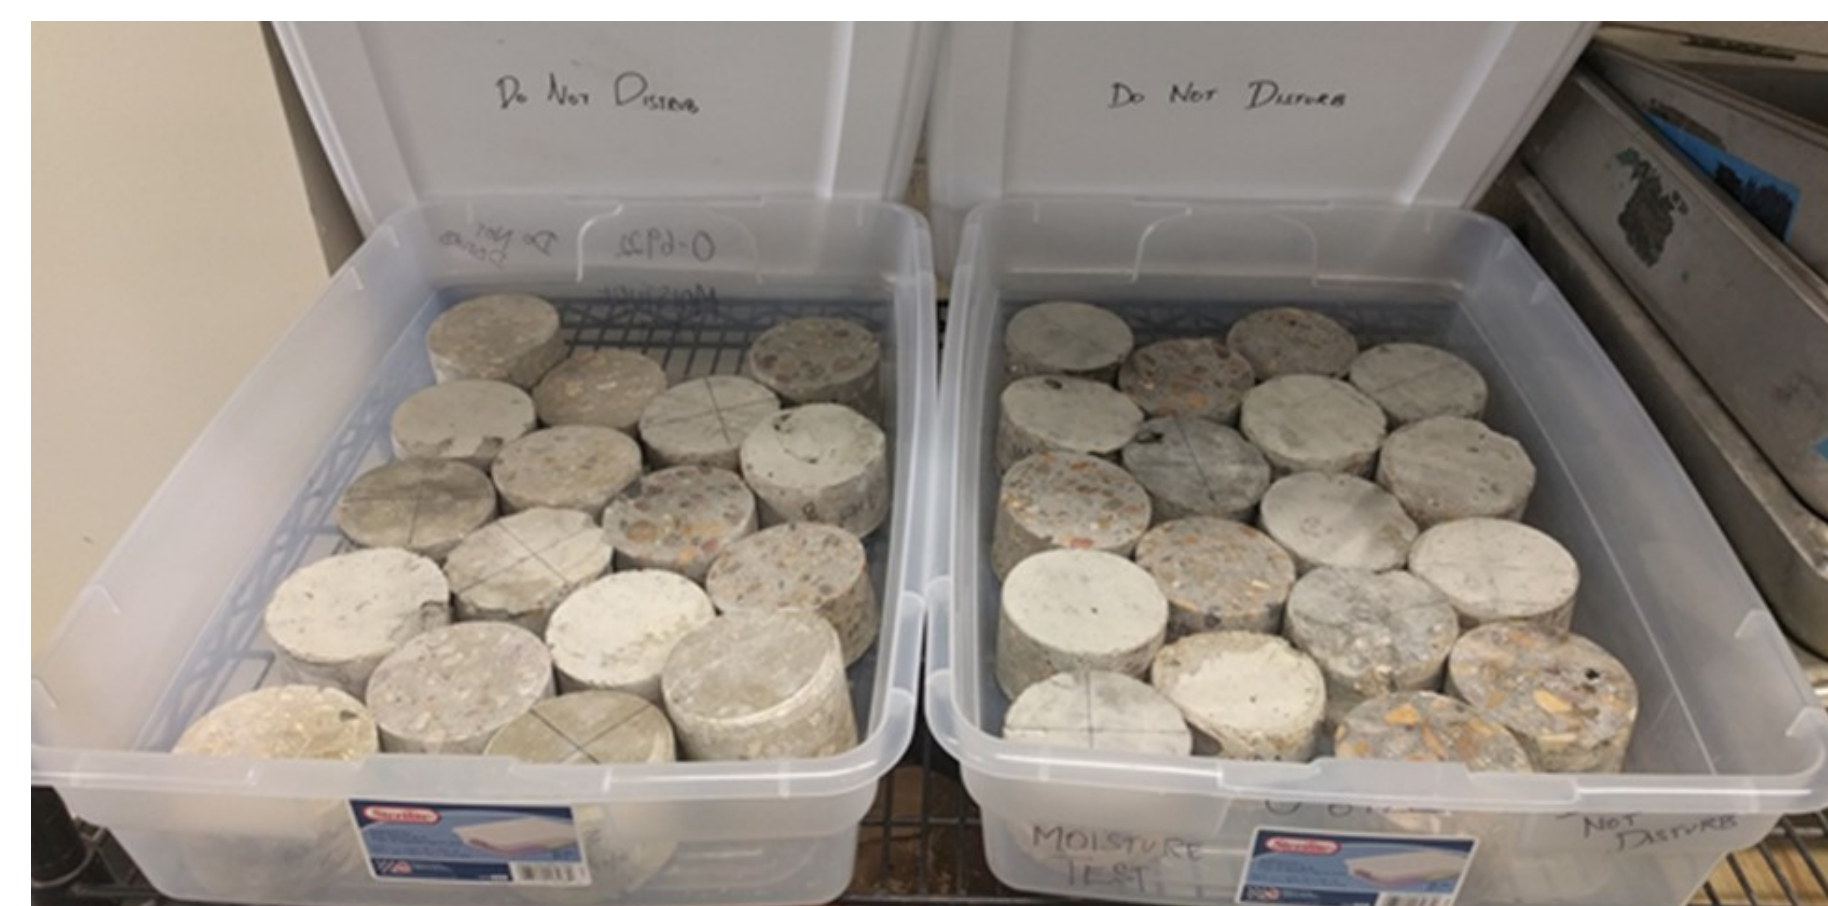
Accelerated Weathering Test

- Determine the factors that have the biggest impact on rate of growth of Microcracking.
- 22 Alternate wetting and drying cycles conducted on samples with various degrees of initial microcracking and non destructive tests were conducted at the end of each:
  - Dry Cycle**—Cracking, Mass and Volume Measurements
  - Wet Cycle**—Mass, Ultrasonic Pulse Velocity (UPV), Bulk Resistivity Measurements.
